Bartlett Carry Dam as Reported February 1994

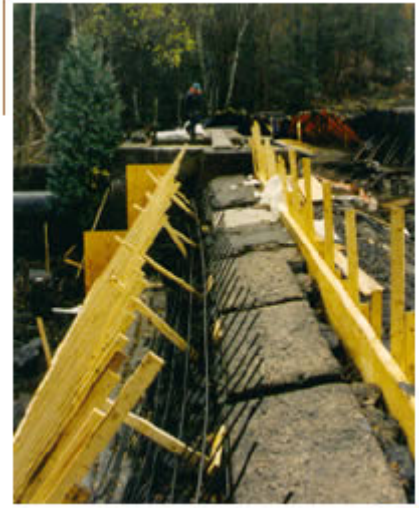
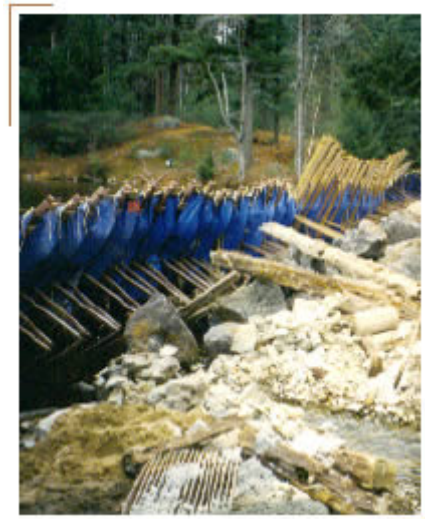
A number of considerations and concessions were made in the design of the dam. First, it had been decided by the dam committee that the functions of the existing dam be maintained as closely as possible. The level of the new spillway is within inches of the old spillway, and is lower on the south side, as was the old spillway. The north spillway was designed with a series of steps to maintain the sound of falling water provided by the old dam.

The entire structure of the repaired dam is much more massive than the old dam. This was necessary to meet all of the rules and regulations of the permitting agencies.

The dam is being repaired in two stages. In late fall, a portable coffer dam was placed in front of the northern half of the dam, and the area was dewatered. Logs and debris were then removed from the upstream and downstream sides of the dam. Upon inspection, interior damage to the dam was found to be more extensive than realized and would have caused failure within three to five years.

In late November, concrete was pumped into forms built around the old dam. The portable coffer dam was removed and water began flowing over the new spillway on December 20.
